# OHIO HISTORIC INVENTORY

1. No. **BUT-116-872**  
 2. County **BUTLER**  
 3. Location of Negatives **CITY OF MIDDLETOWN**  
 4. Present Name(s) **AMERICAN RED CROSS - MIDDLETOWN CHAPTER**  
 5. Other Name(s) **GEORGE SHAFOR HOUSE**

6. Specific Location  
**LOT 125 S. MAIN STREET  
 (LOT 64, PARCEL 34  
 LOT 65, PARCEL 133, WARD 1)**

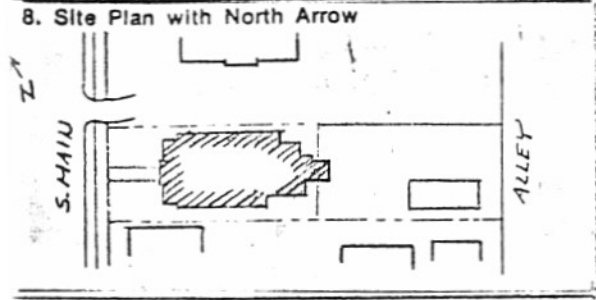
2. Further Description of Important Features  
**EXTERIOR STAIR TO CONCRETE BASEMENT, GREEK PORCH, SAND COLORED BRICK, PINNACLED WOOD DORMER GABLES, 2 CHIMNEYS WITH BLACK WROUGHT IRON CHIMNEY SUPPORTS, PORCH HAS DETAILED WOODWORK, TILE (CERAMIC) PORCH FLOOR, STAINED AND LEADED GLASS, COVERED BALCONY AND PORCH IN CORNER OF BLDG.**  
**40' x 80' x 40' HIGH**
