OHIO HISTORIC INVENTORY

No. **54 BUT. 98 .8**
County **BUTLER**
Location of Negatives
CITY OF MIDDLETOWN

4. Present Name(s)
317 S. MAIN STREET
5. Other Name(s)

Name of Established District
S. Main Street Historic District

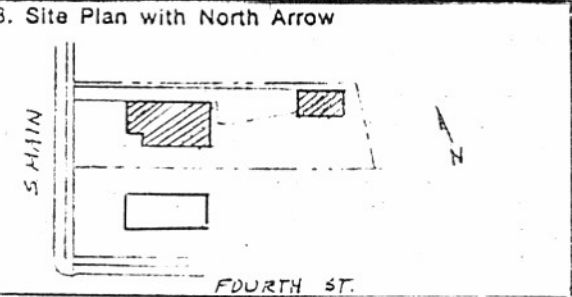
Further Description of Important Features
ALTERED TO HOUSE 3 APARTMENTS, GREEK DORIC PORCH COLUMNS WITH ENTABLATURE, PEDIMENT STYLE ROOF ON BOTH HOUSE AND PORCH, ALUMINUM WINDOWS.
30' x 45' x 24' HIGH
