# OHIO HISTORIC INVENTORY CODED

4. Present Name(s) Holy Trinity Catholic Church  
5. Other Name(s)

6. Specific Location  
201 Clark St.  
7. City or Town If Rural, Township & Vicinity  
Middletown

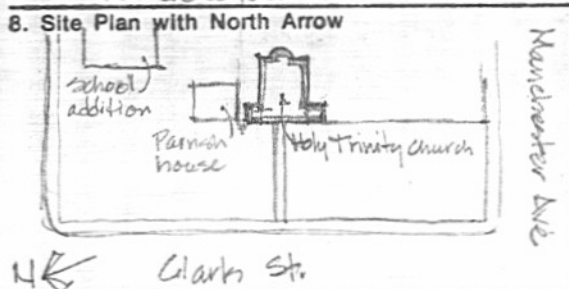
42. Further Description of Important Features  
The foundation and walls are of rock faced sandstone. There are 2-story stained glass windows on 3 sides of the church and an apse at the east end. There is a spire on the south west corner and a large round arched entrance with oak doors. The additions include a porch on the south-west corner, and an entrance way on the northwest corner next to the parish house.
