OHIO HISTORIC INVENTORY

1. No. BUT233111		2. County Butler		4. Present Name(s) Pumphrey Barn		1. No. BUT233111
3. Location of Negatives Ohio Historic Preservation Office				5. Historic or Other Name(s) Scott, John, Barn; Robinson Barn		
Roll No.		Picture No.(s) 11-27

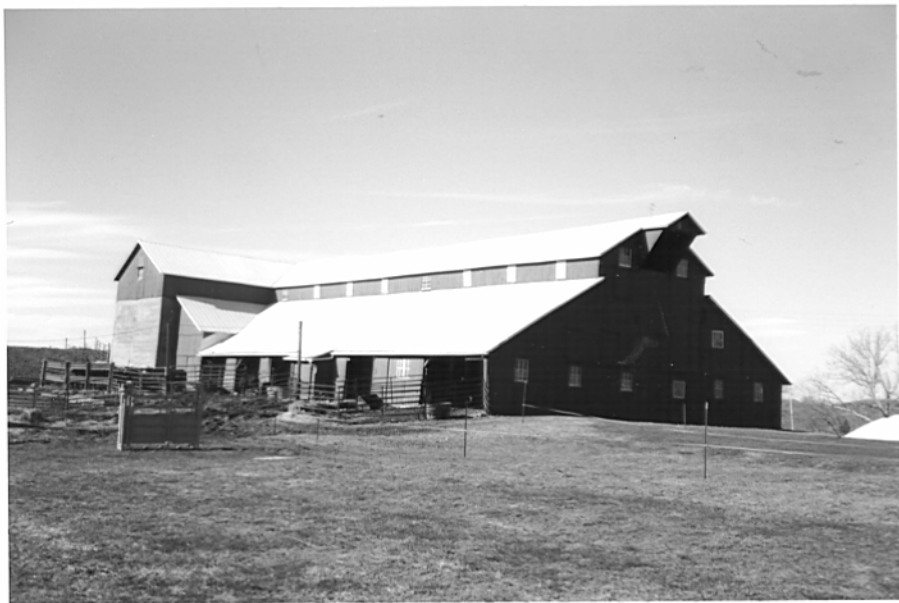
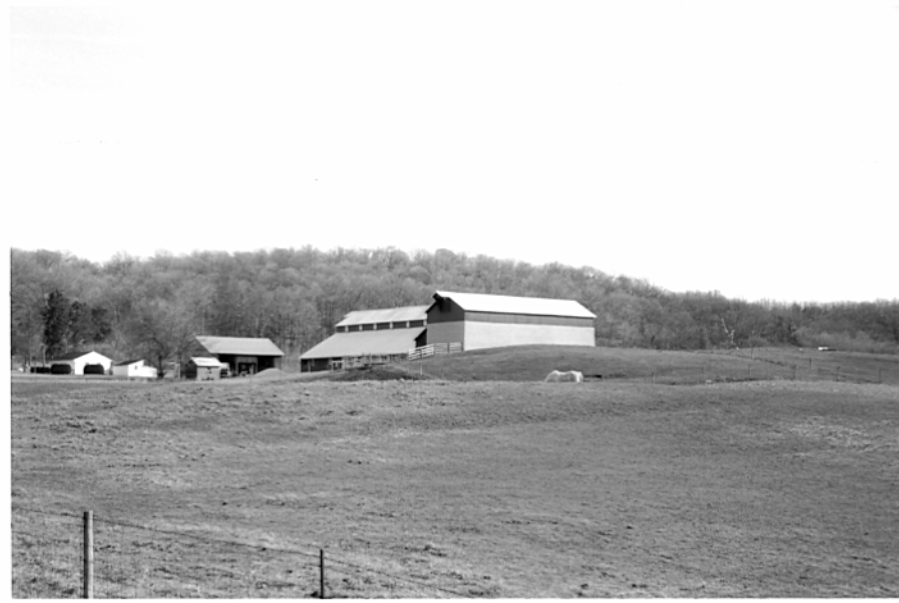
11-27

39. Endangered? No By What?		
				40. Chimney Placement No chimney observed		
				41. Distance from & Frontage on Road		
42. Further Description of Important Interior and Exterior Features (Continued on Reverse if Necessary) A combination cattle barn and three square concrete silos, all constructed in 1884 and in a remarkable state of preservation. The silos, banked into the east side of a small knoll, consist of three 24' x 24' concrete cells for storing silage. The concrete walls are 2' thick and are surmounted by a common gable roof. The barn measures 72' x 104' and the lower level features three feed alleys following a north-south alignment and a row of box stalls along the east wall. A driveway separates the continued...						6. Specific Address or Location 3681 Hamilton-New London Rd

cattle area and the silos. The feeding stanchions appear to be early 20th century. All of the framing members are sawn. Floor joists measure 2 inches x 4 inches. The haymow comprises the monitor-shaped portion of the barn and exhibits a large hay hood at the east gable end. The framing members are all sawn and a combination of heavy timbers and lighter framing. Curiously, it would seem the original tie beams in the haymow were sawn off below the roof peak soon after completion of the barn. A list of barn construction and materials expenses indicated a hay carrier was purchased, so it seems probable that Scott discovered the tie beams interfered with efficient operation of the new hay carrier and had portions of the tie beams removed.
