OHIO HISTORIC INVENTORY

1. No. BUT233711		2. County Butler		4. Present Name(s) Pumphrey Milk House		1. No. BUT233711
3. Location of Negatives Ohio Historic Preservation Office				5. Historic or Other Name(s) Henry Robinson Milk House		
Roll No.		Picture No.(s)

6. Specific Address or Location 3601 Hamilton-New London Rd				16. Thematic Associations: AGRICULTURE Dairy Farm		2. County Butler
				28. No. of Stories One story		
6a. Lot, Section or VMD Number Section 30				17. Date(s) or Period c. 1915		29. Basement? No

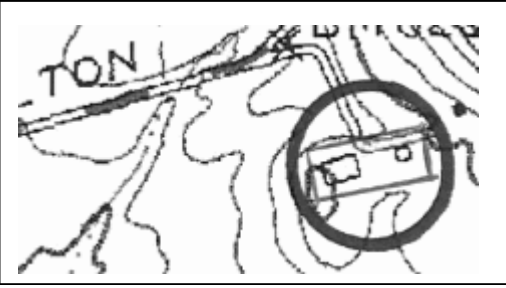
7. City or Village Ross (Township of)				17b. Alteration Date(s)		30. Foundation Material Concrete slab
8. Site Plan with North Arrow

42. Further Description of Important Interior and Exterior Features (Continued on Reverse if Necessary) Located immediately north of the barn, the milk house is a ca. 1915 single room, one story gable-roofed structure constructed of glazed brown, vermiculated tile. A single door marks the south gable end facing the barn. The corrugated metal roof is a recent installation. The interior featured a concrete trough that when filled with spring water kept the milk cans cool. During the 1950s the Board of Health closed the milkhouse and a new electric powered milk cooler was built on the barn's west continued...						6. Specific Address or Location 3601 Hamilton-New London Rd

44. Description of Environment and Outbuildings (See #52) The milk house is located on the historic Halstead - Scott-Robinson farm. The Scott Barn [BUT-2331-11] and the Scott Granary [BUT-2332-11] are south of the milk house.

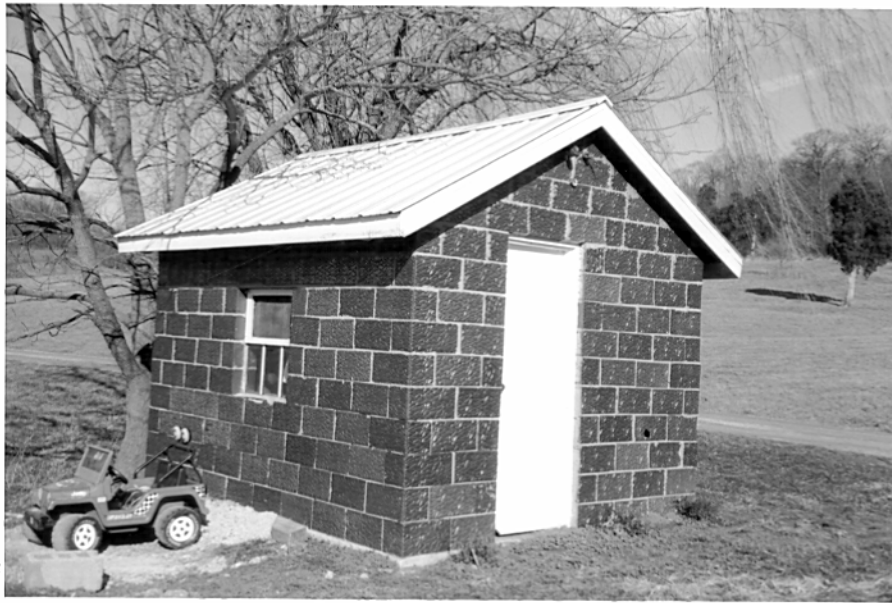
42. Further Description of Important Interior and Exterior Features (Con't)
elevation. This addition was removed in the 1990s.
